# **Gravel Road Test Sections Insulated with Scrap Tire Chips Construction and First Year's Results**

Robert A. Eaton, Richard J. Roberts and Dana N. Humphrey    August 1994

**U.S. Army Corps  
of Engineers**  
Cold Regions Research &  
Engineering Laboratory

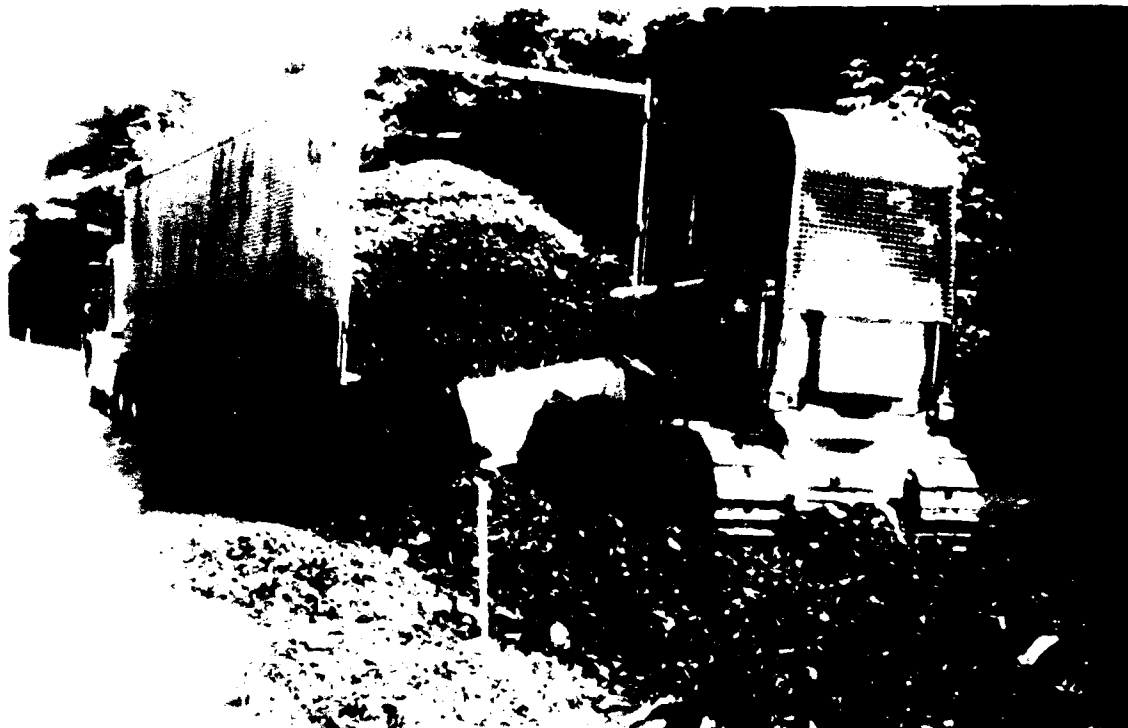
*Figure 7. Unloading tire chips from the semi-trailer and spreading them with the small bulldozer.*

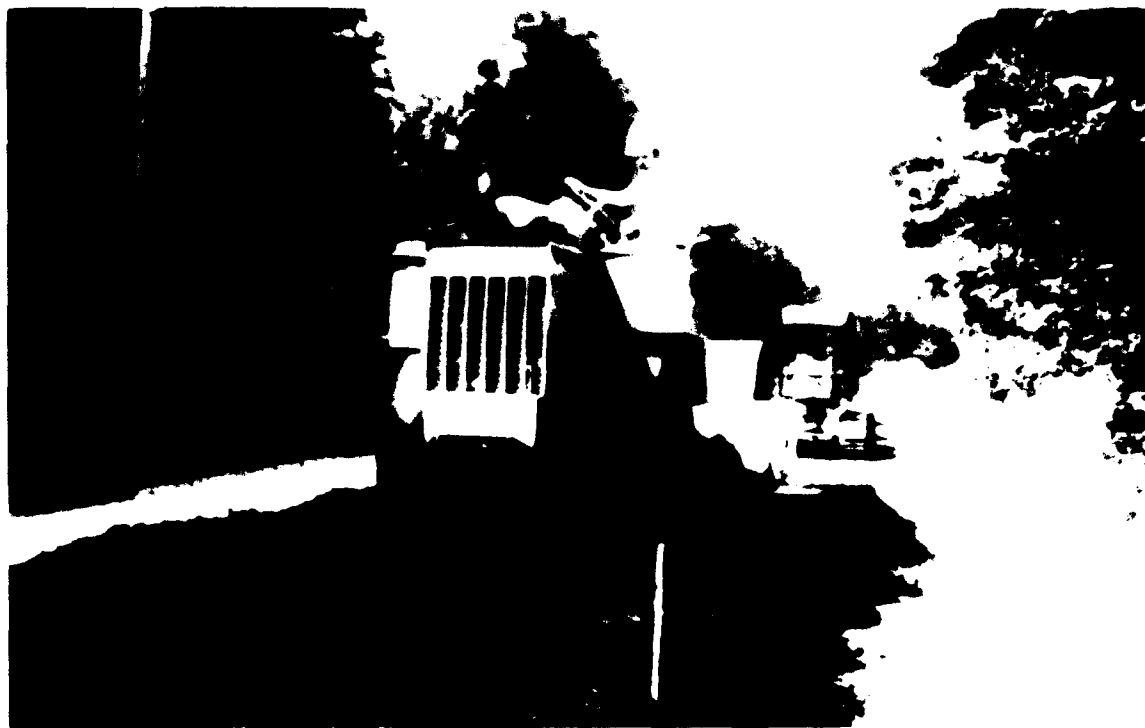
Figure 8. Compacting the tire chips with the vibratory roller.

row were hauled to the site in 15-yd<sup>3</sup>-capacity dump trucks, spread in a 12-in. maximum thickness lift by the small bulldozer, and then compacted with six passes of the roller.

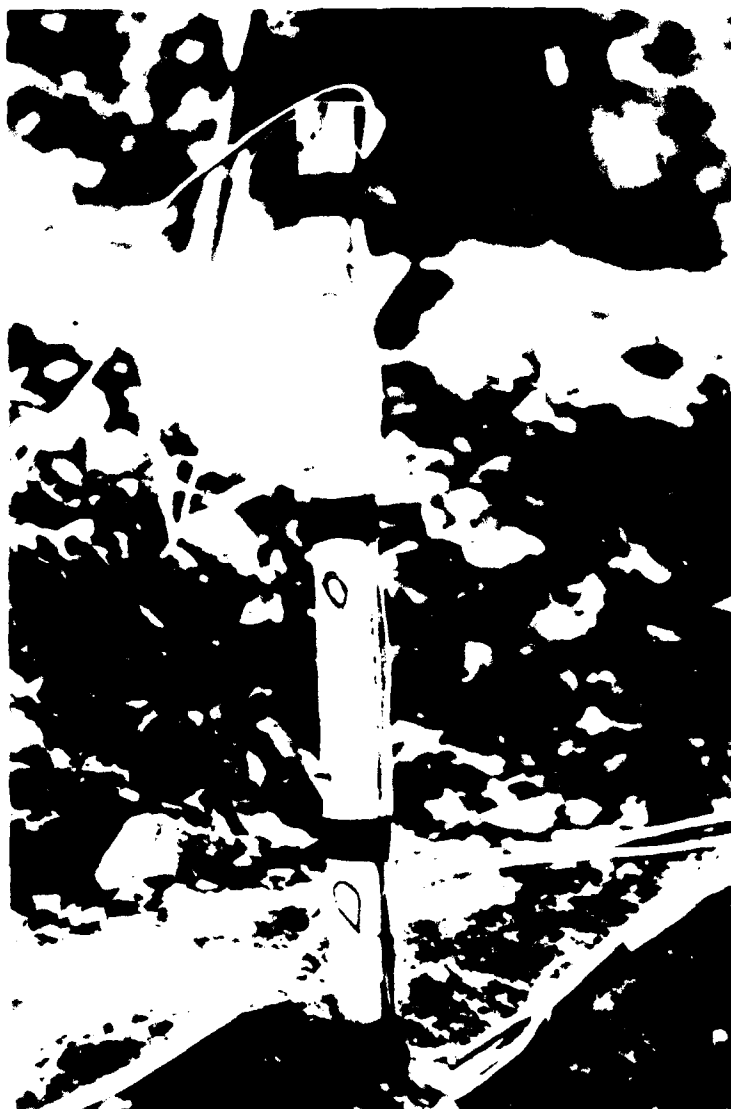
Figure 12. Portion of a thermocouple string that will extend through the tire chip layer.

Two vertical strings of thermocouples are installed in each test section, the control section and the adjacent original, undisturbed roadway. Each string consists of twelve 20-gauge copper constantan thermocouples, whose spacings vary from 3 in. near the road surface to 12 in. at greater depths. The deepest thermocouple is typically about 6 ft below the road surface. An installation in a typical section (section C) is shown in Figure 11. To maintain the desired spacing, the thermocouples were mounted on a 1-in. diameter wooden dowel and installed in a 5-in.-diameter hole drilled with a trailer-mounted power auger. After placing the string, we backfilled the hole with native soil that was tamped in place with a hand tamper. The portion of a thermocouple string that will extend through the tire chip layer is shown in Figure 12.

The electrical resistivity gauges consist of 1-in.-diameter copper rings spaced 2 in. apart on an epoxy filled core. The electrical resistance of the soil between adjacent rings is measured to determine if the soil is thawed or frozen (the reading for frozen soil is much higher than for thawed soil). This allows us to monitor the location of the freezing front and, during the spring, the thawing front. The resistivity gauges were 4 ft long. The top of the gauge was typically even with the bottom of the tire chip layer. The installation technique was the same as for the thermocouples (Fig. 12).

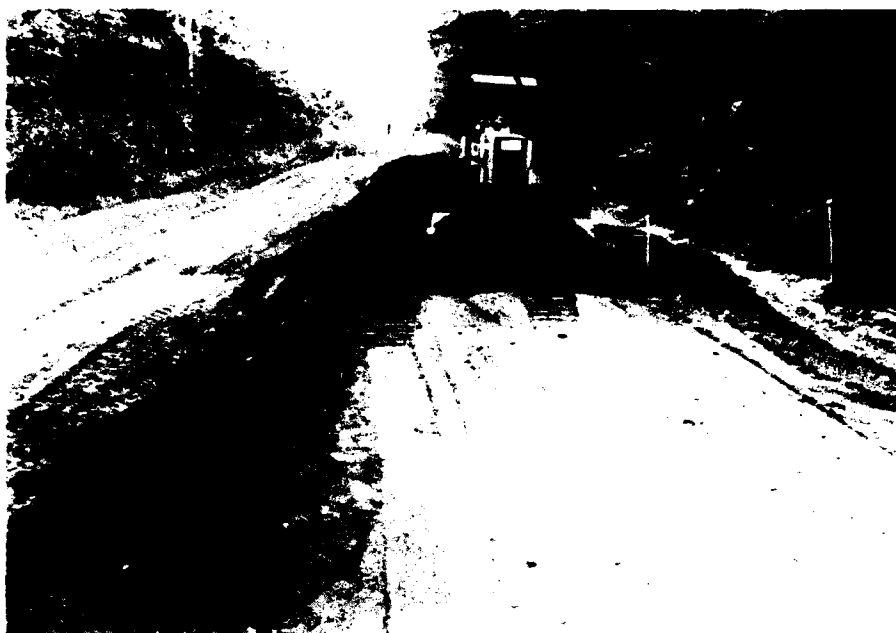
*Figure A3. Fine grading the tire chips.*

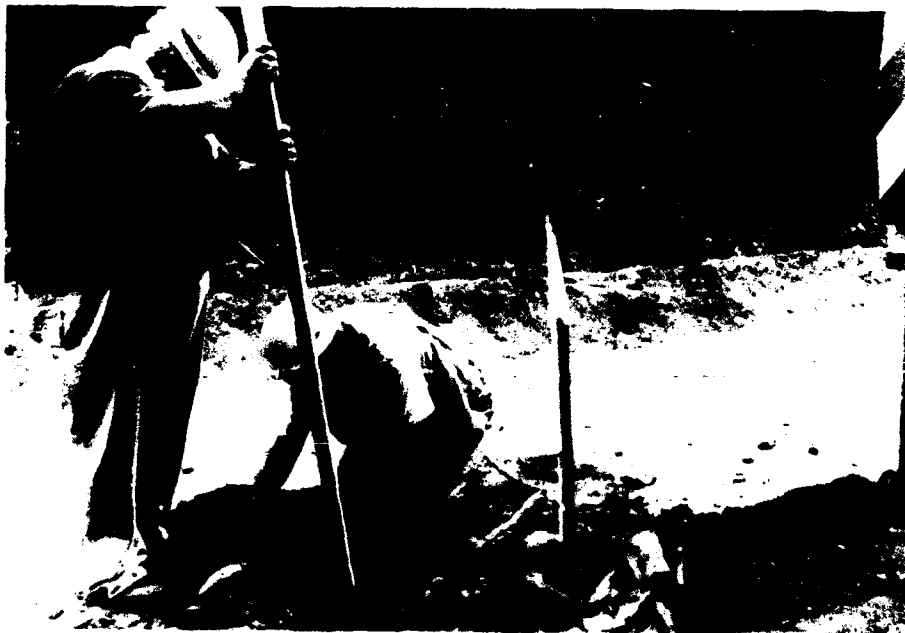
*Figure A6. Compacting the soil around a thermocouple string.*

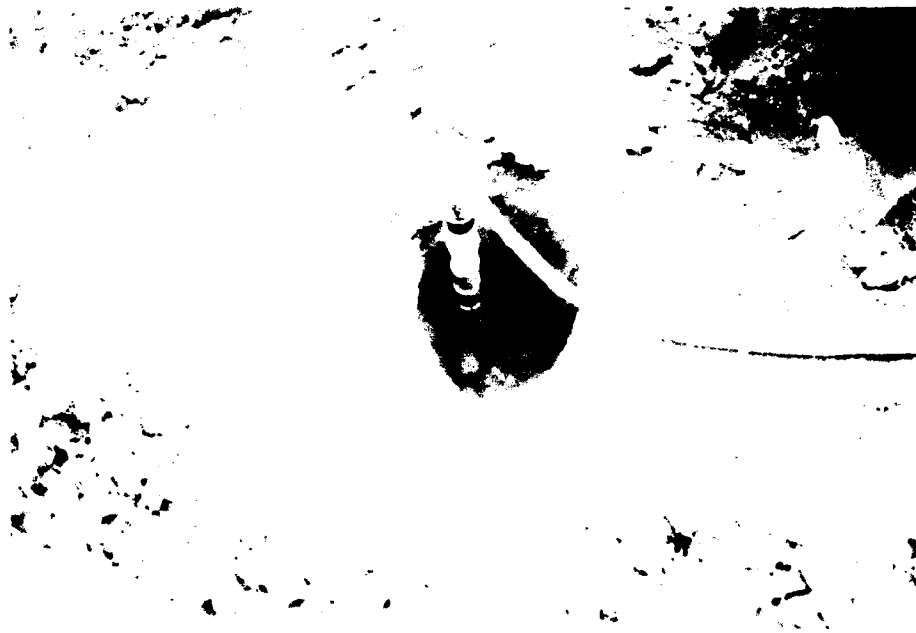
*Figure A7. Resistivity gauge placed in subgrade.*

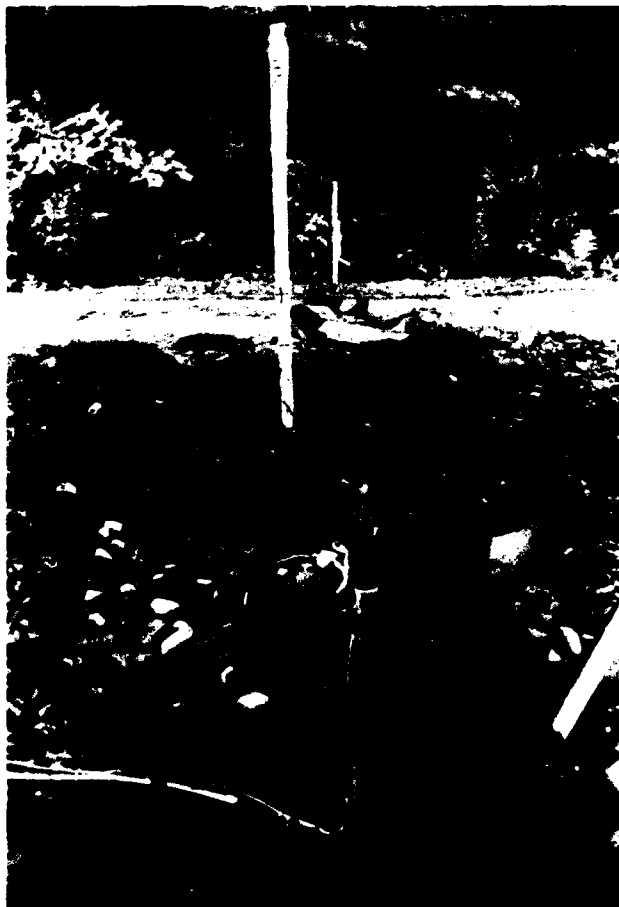
*Figure A8. Thermocouple string with three fliers to be placed in overlying gravel.*

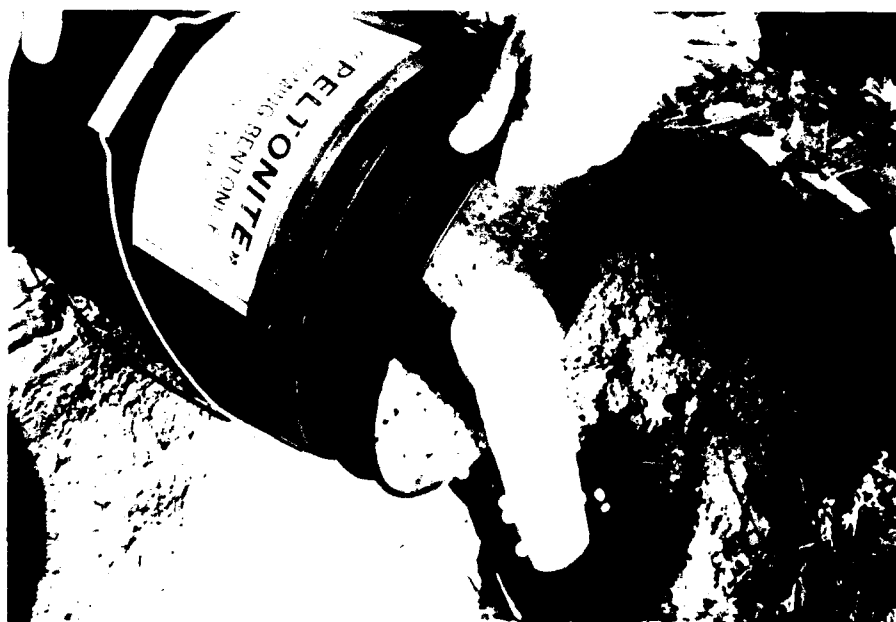
*Figure A10. Putting bentonite around water wells to seal against surface water infiltration.*

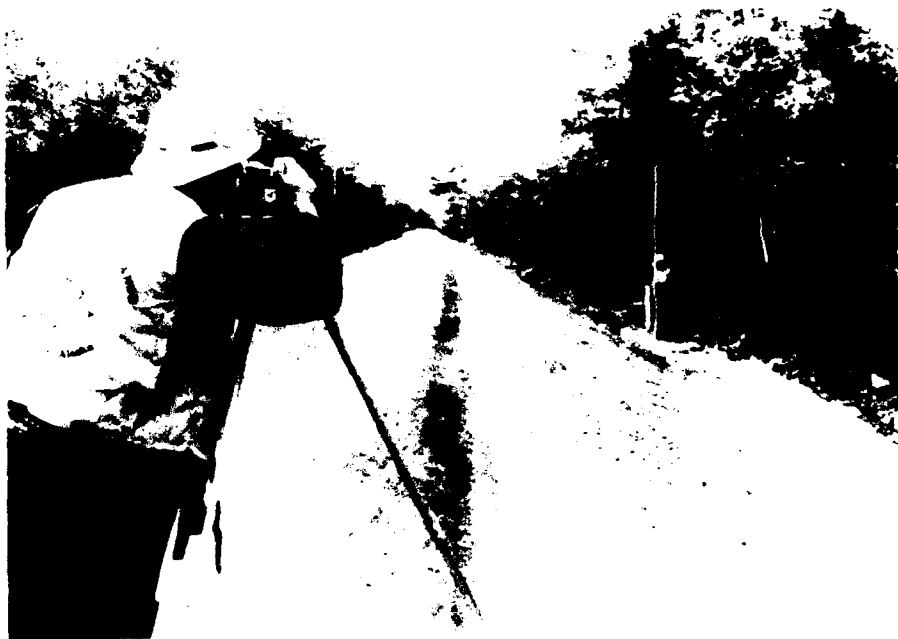
*Figure A14. Level surveys to measure frost heave.*

The heave of the road surface will be measured several times during the winter with a level survey. The two frost-free benchmarks were installed to provide stable reference points for this survey. The frost heave of the different sections are compared. All survey points are given in Appendix D.

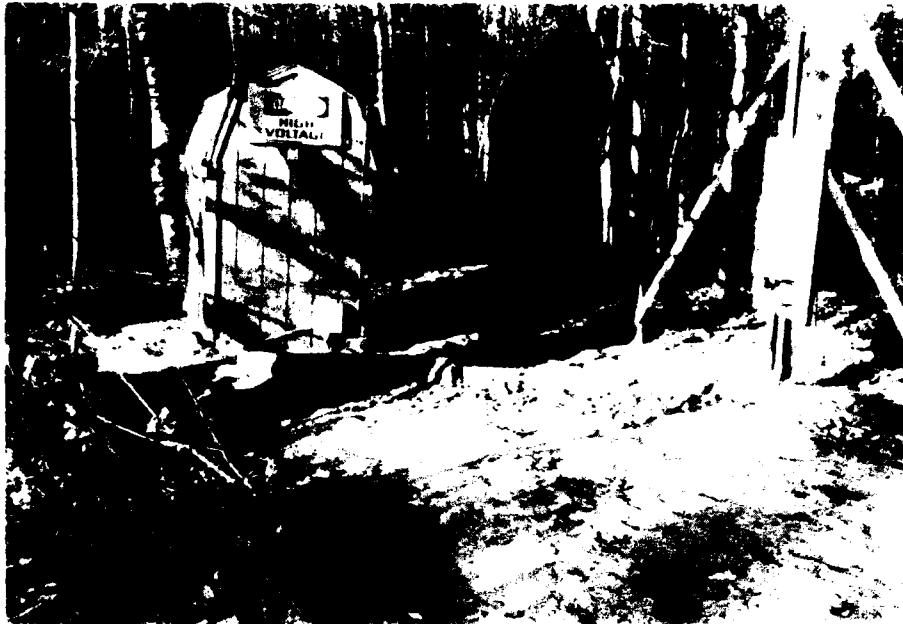
*Figure A17. Instrumentation shelter where data are collected and sent to CRREL via phone lines.*
